## VacuFlush Toilet - Preventative Maintenance

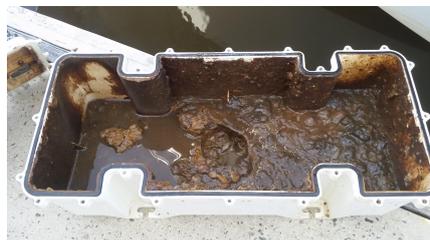
A very common field problem in this type of toilet is the introduction of foreign material into the line, causing vacuum leak or line blockage. Foreign material can damage the rubber seals, vacuum pump, pressure switch, or other components. It can even rupture the vacuum tank in severe cases. Subsequently, fault finding and repair becomes a costly exercise. Below is an example of a blocked system where fabric material was flushed into the toilet. The vacuum generator tank had to be dismantled to trace and repair the fault.
